CIVIL AERONAUTICS BOARD

ACCIDENT INVESTIGATION REPORT

EASTERN AIR LINES, INC. AND P-38 AIR COLLISION—NEAR WASHINGTON
NATIONAL AIRPORT, WASHINGTON, D. C., NOVEMBER 1, 1949

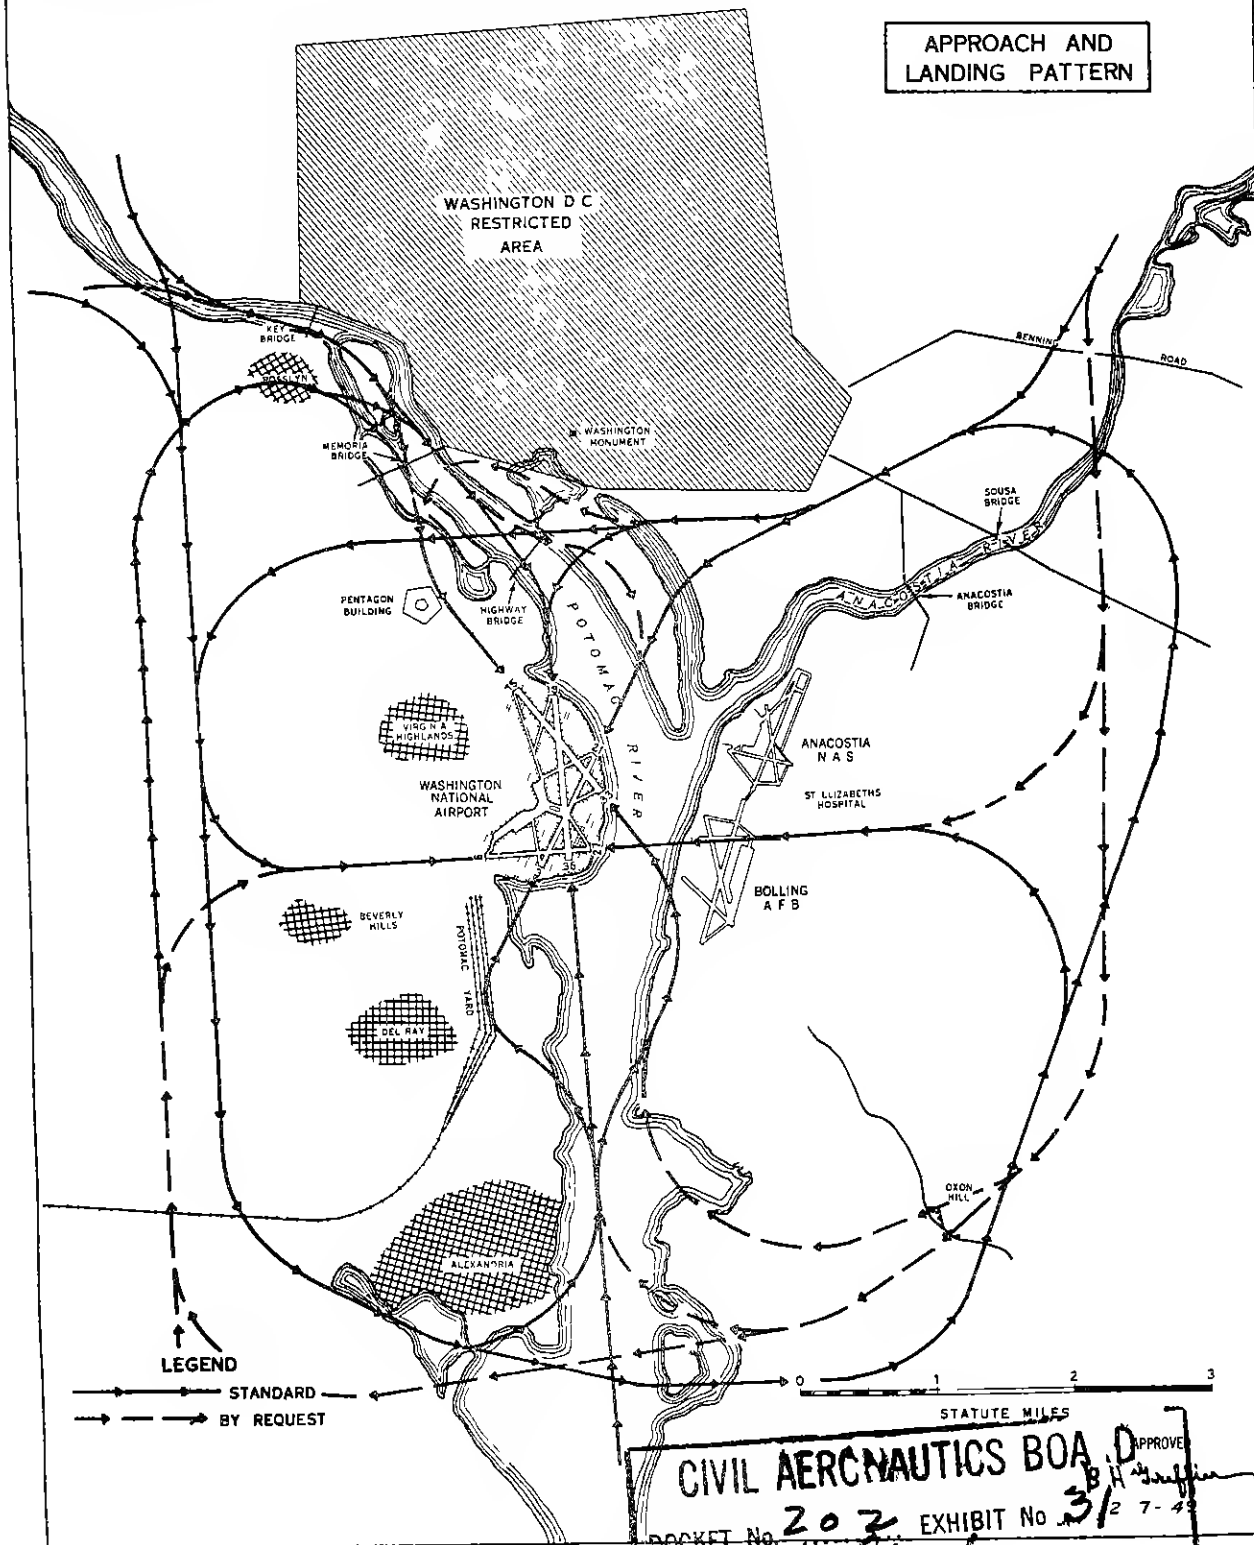
APPROACH AND LANDING PATTERN

1 Remain above 1200' until over Potomac River, make approach over Potomac River, make left turn upon passing PEPCO plant, and line up with Runway 3
